**20-year Budget, Infrastructure Assessment,  
and Major Capital Replacement Plan**

**Community Resource Services of Colorado**

**May 2015**

**Revised January 2018**

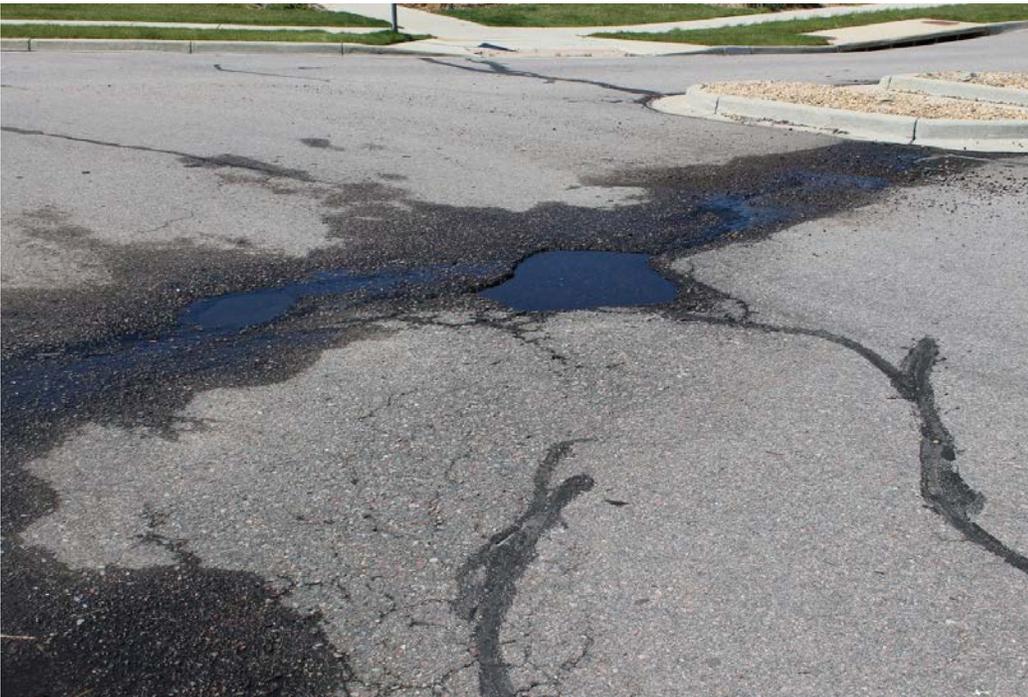
### Traffic Circle North Edge

As can be seen in the picture above, the roadway has begun to severely deteriorate with a large pot hole in the wheel lane on the North side of the traffic circle. One can also detect alligator cracks are beginning to develop. This situation is caused by a significant amount of water running off the landscaped traffic circle. It is recommended that this area be removed and replaced as soon as possible to prevent further damage to the roadway.

**In 2017, DWMD contracted with Brown Brothers Asphalt & Concrete in the amount of \$11,841 to remove and replace the asphalt at the Traffic Circle.**

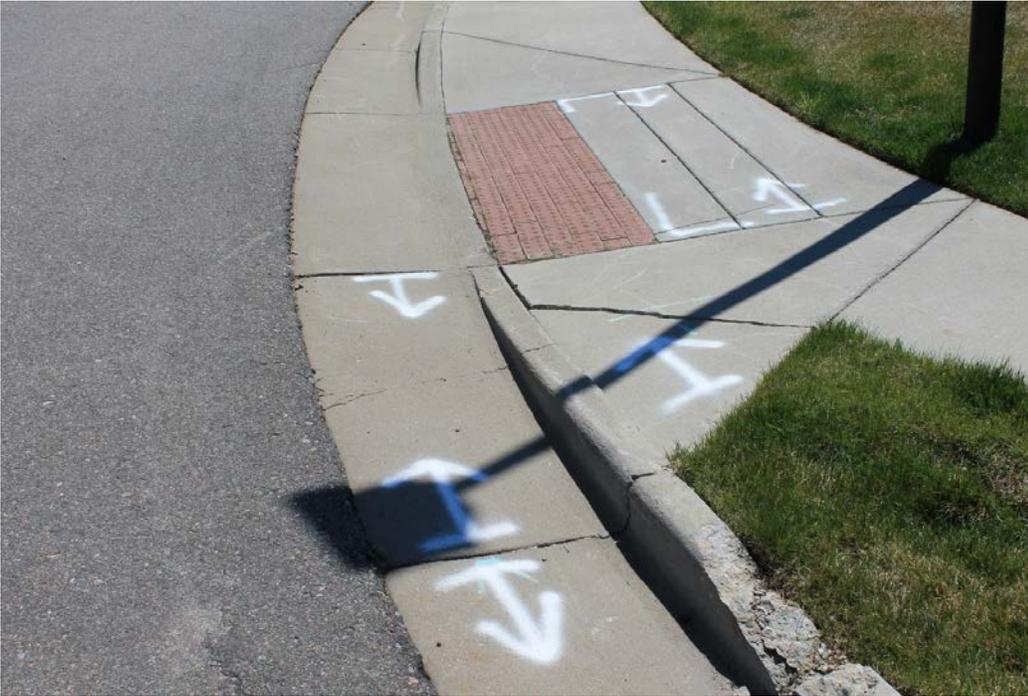
### Handicap Ramp near South Taft Street and Ida Avenue

As can be seen this ramp exhibits numerous cracks and has several trip hazards. It is unclear if this is to be repaired by Jefferson County or DWMD as both Taft Street and Ida Avenue are public streets.

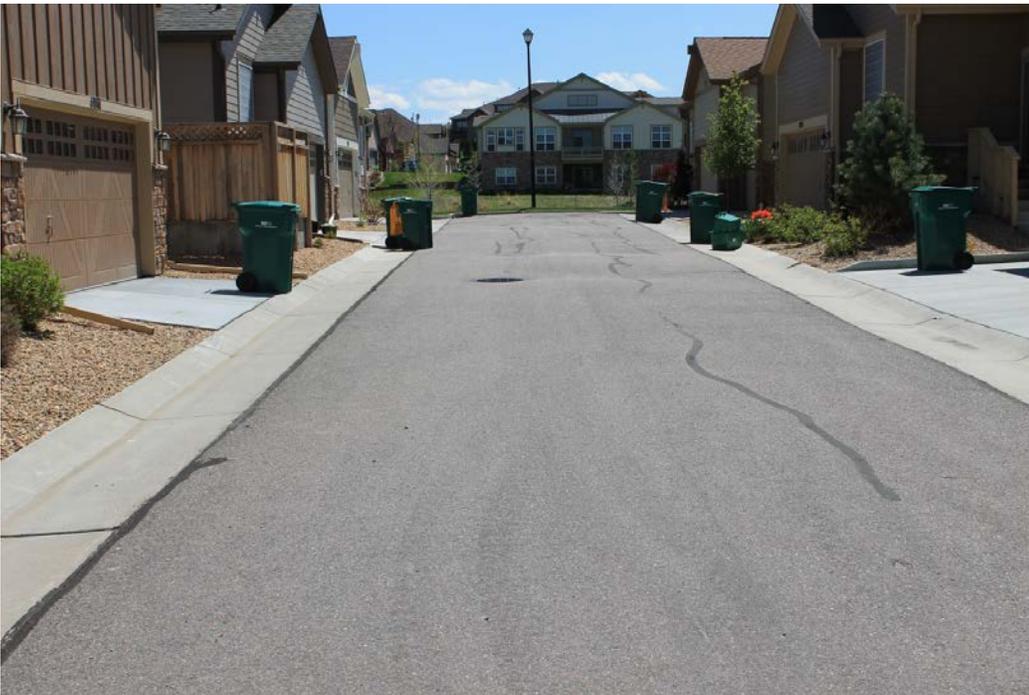
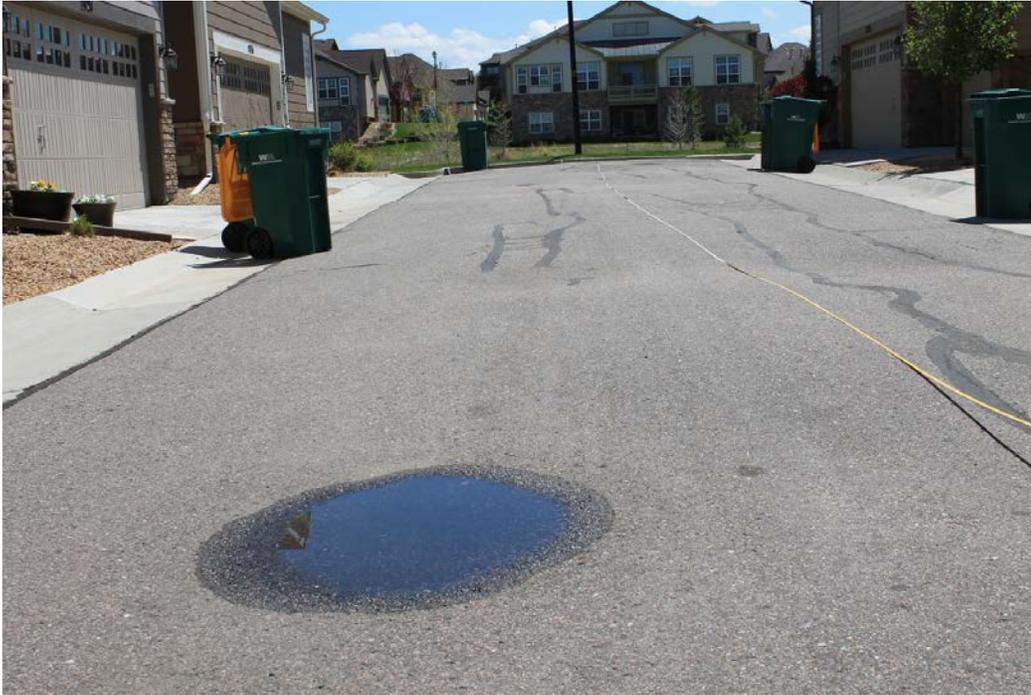
**Union Lane**

The street that will require the greatest expense is Union Lane. This street exhibits significant heaving caused by expansive soils beneath the street. The only effective way to repair this street is to remove all asphalt overlay, dig out approximately 12" of Native soil and replace that soil with compacted road base and then overlay the road base with 4" to 6" roller compacted asphalt. As can be seen from the photos below this street needs reconstruction.

Note: Observe the rippled asphalt with numerous undulations

**In 2016, DWMD contracted with Brown Brothers Asphalt & Concrete to perform asphalt replacement/repairs on S. Union Lane at a cost of \$33,335.**

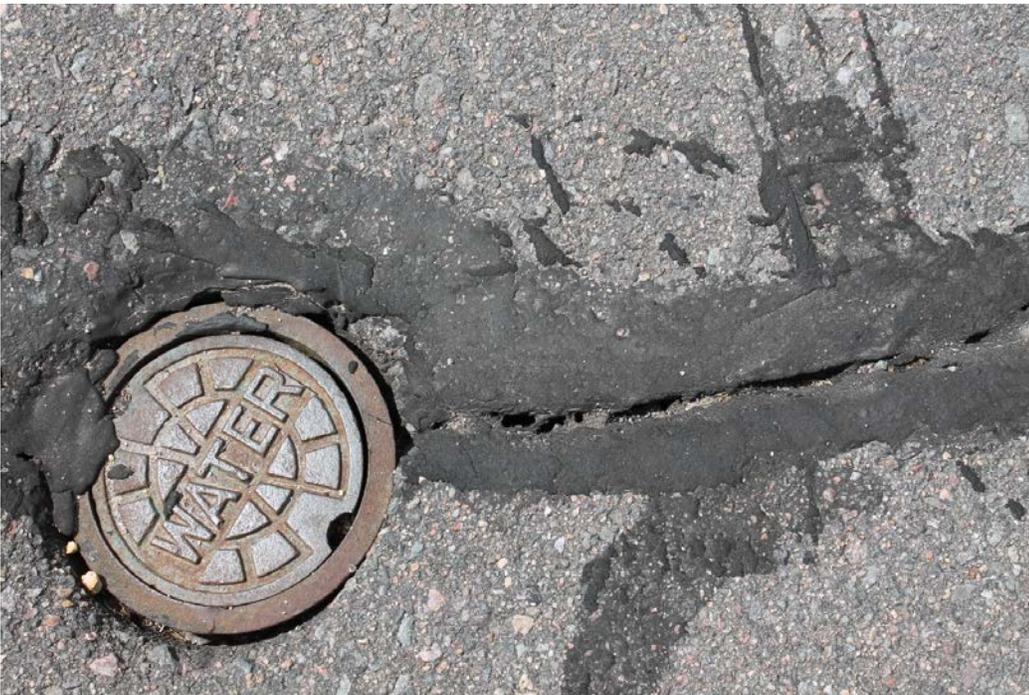
**Valve Box located on Gould Loop near and West Gould Place**

As can be seen water can easily enter the previously filled cracks and cause further damage to this roadway which is otherwise in good condition. A contractor should be hired as soon as possible to perform a thorough crack fill.

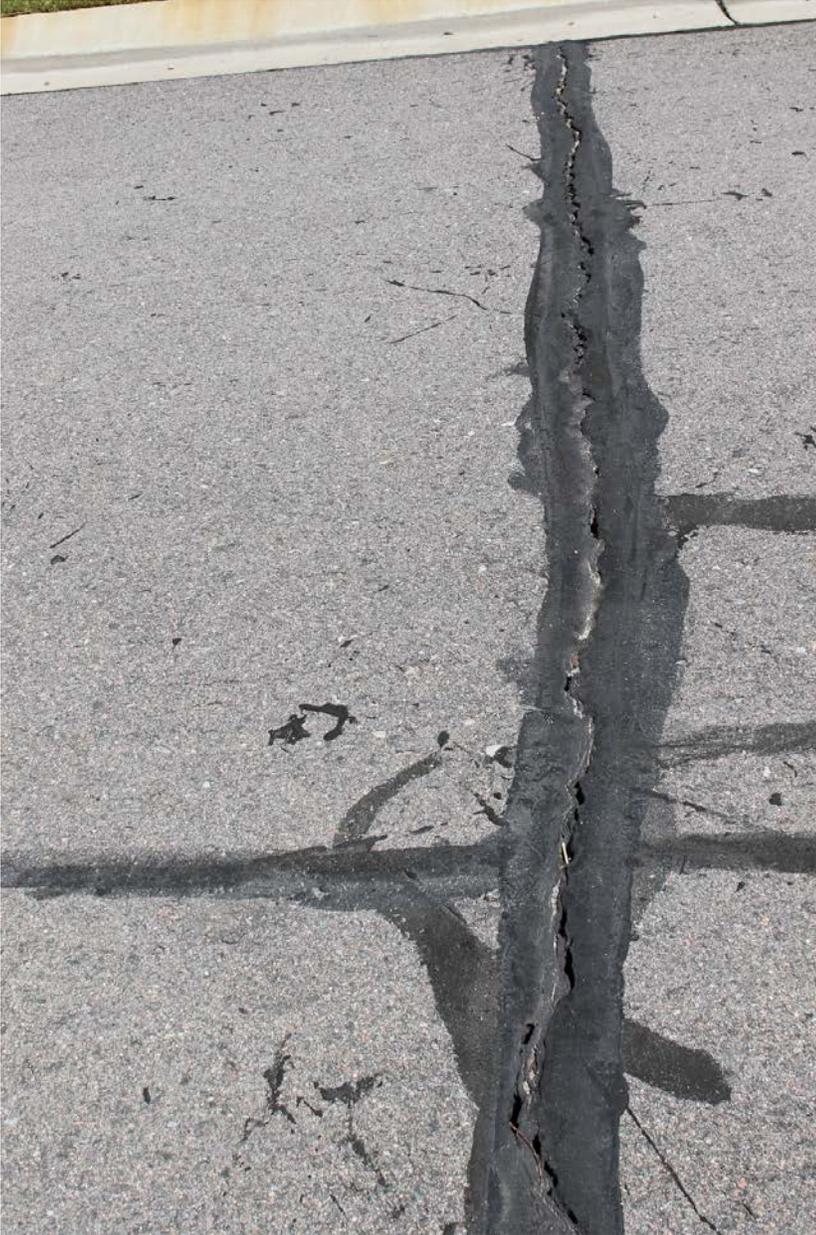
**Gould Loop near and West Gould Place**

As can be seen in several attached pictures the existing crack fill needs to be reworked to close gaps.

In addition to crack sealing the streets on an annual basis, it is also suggested that DWMD apply a slurry seal to the streets to seal the surface of the streets and buy additional time before a full overlay needs to be applied. The cost to apply slurry seal ranges in cost from \$0.40 - \$0.68 per square foot in the Littleton area. DWMD has approximately 265,461 square feet of roadway. Therefore, the cost to slurry seal DWMD's roads will range from \$107,145 to \$180,544 in 2015 dollars. By Seal coating the streets, additional longevity can be gained which will allow DWMD to save the money needed to mill and overlay all their streets in about 10 years.

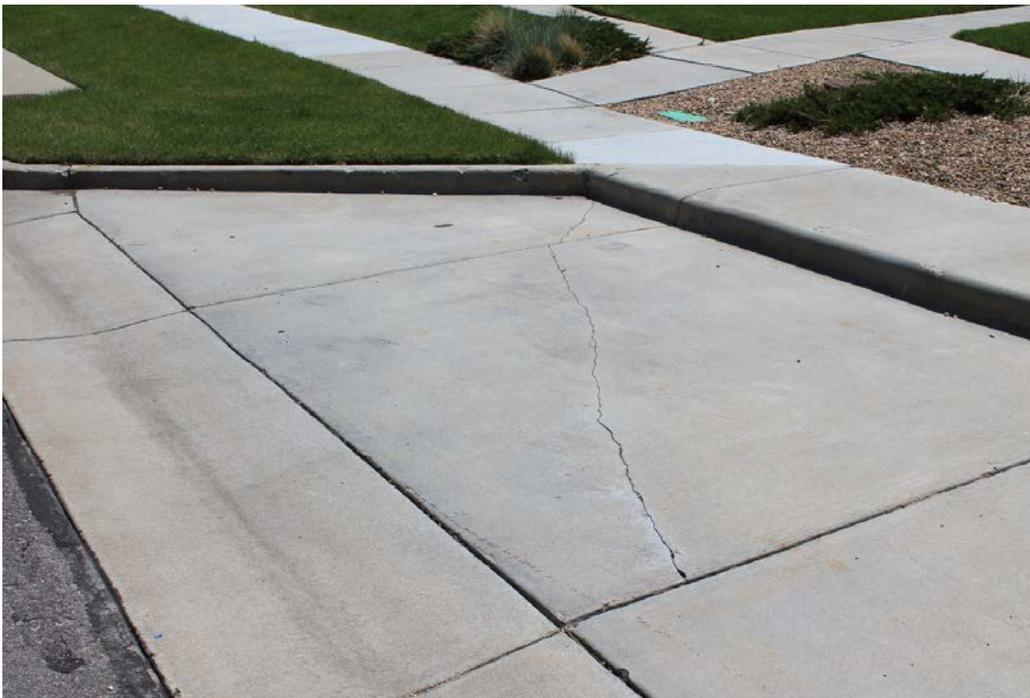
### **Minor Cracking on Gould Loop**

There are numerous concrete parking areas throughout DWMD. Most are in very good condition; however, there are a couple of areas along Gould Loop that need to, at the very least, have the cracks grouted to prevent moisture from entering into the crack and causing further damage. The parking area near the Dancing Willows pool is more extensively damaged and that panel should be removed and replaced.

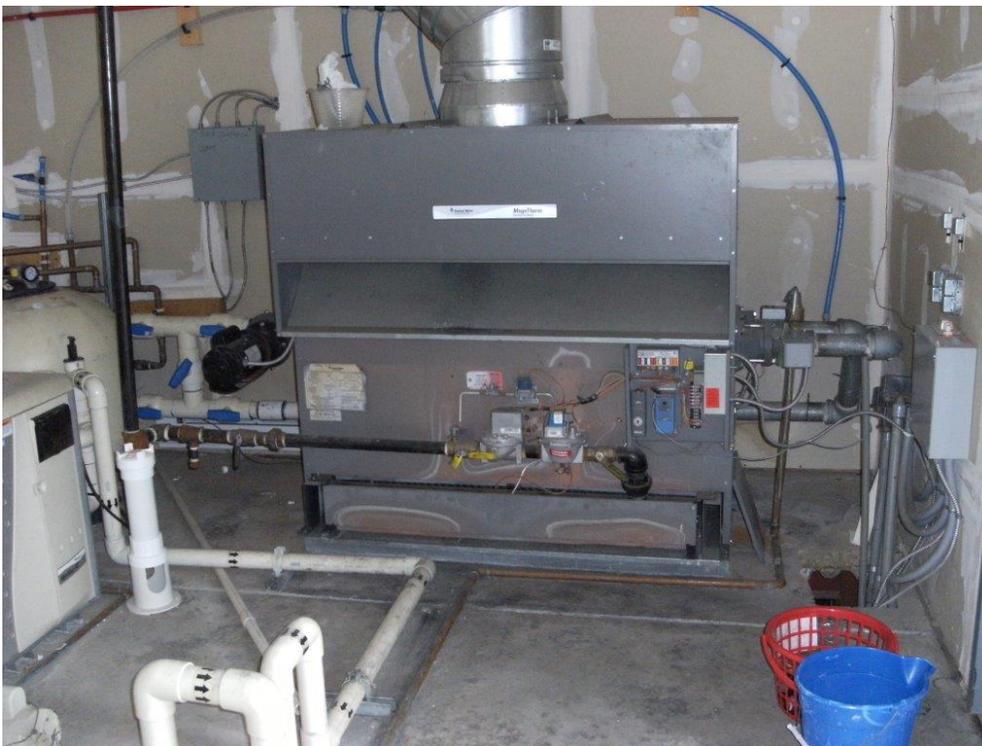
Based on the manufactures tag, shown below, the existing boiler is a Megatherm 1010 Natural Gas heater capable of producing 1,010,000 BTU/Hour and is designed to deliver efficiencies of up to 82%. The replacement cost of this boiler is \$9,384.81 plus approximately \$2,000 for installation. The life expectancy of this unit, in a seasonal application such as Dancing Willows, is approximately 10 years. Given this, DWMD should expect that this boiler unit may need to be replaced in the next 2-4 years. There are other more efficient boilers available with up to 97% efficiency. The cost of a more efficient boiler would be approximately \$22,000, however, the cost of fuel would be significantly less. **The boiler was replaced in 2016 at a cost of \$22,180.**

Manufactured Date:	May 07, 2007
National Board Number:	184553
Serial Number:	C 07 184553
Maximum W.P. Water:	180 P.S.I.
Maximum Water Temperature:	240 °F
Minimum Relief Valve Capacity:	819 lbs./hr.
Heating Surface:	80 sq. ft.

Model Number	MT1010N09C1PCJX
Type of Gas	NATURAL Gas
Input	1,010,000 Btu/hr
Output	816,100 Btu/hr
Min. Input	252,500 Btu/hr
Altitude From	0 to 2000 Feet
Maximum Gas Orifice Size	44
